# FLOOD PLAIN INFORMATION, EAST BRANCH, PERKIOMEN CREEK AND INDIAN CREEK, BUCKS AND MONTGOMERY COUNTIES, PENNSYLVANIA

THIS REPORT WAS PREPARED FOR BUCKS COUNTY AND MONTGOMERY COUNTY PLANNING COMMISSIONS BY U.S. ARMY CORPS OF ENGINEERS, PHILADELPHIA DISTRICT

REPT. NO: DAEN/NAP-82040/FPI32-74/10  
OCTOBER 1974

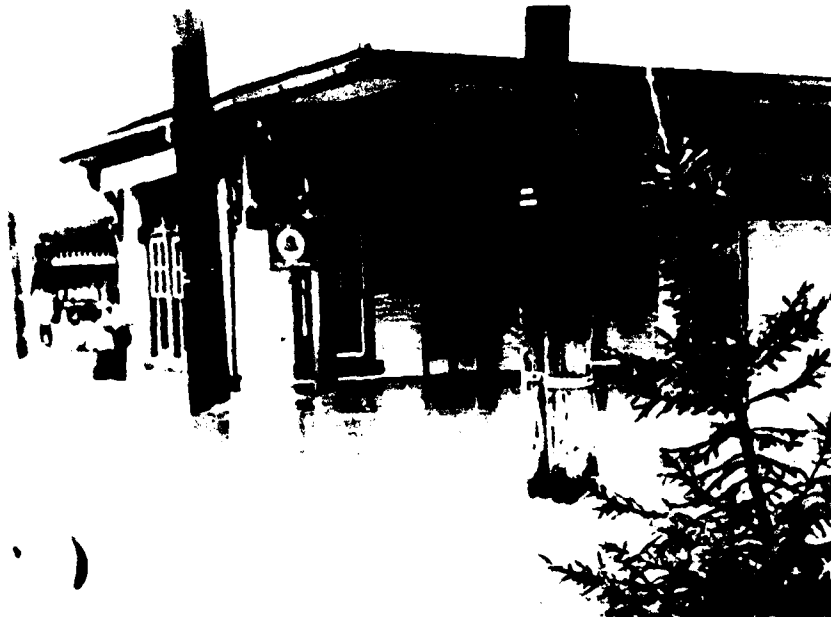
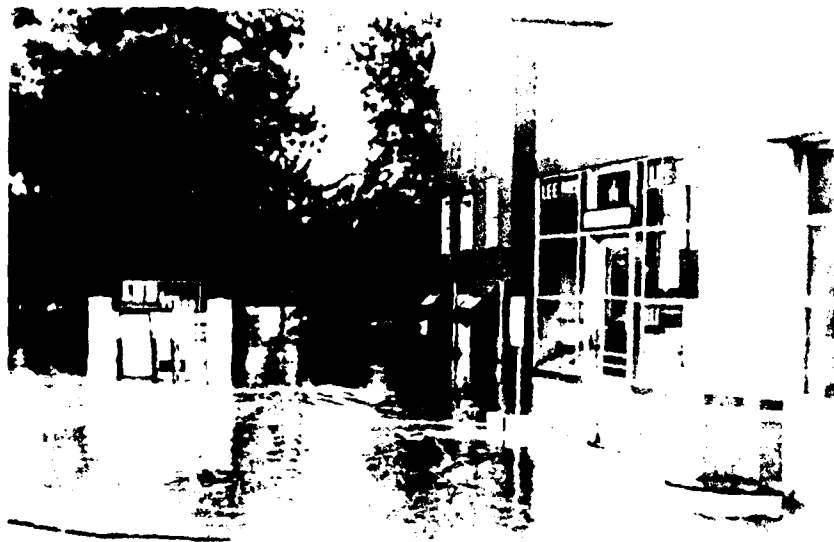
FIGURES 2 and 3 - Sellersville area during the August 9, 1942, flood.

August 9, 1942 - Heavy rainfall which began late on August 8th and continued into August 9th caused serious flooding on the East Branch Perkiomen Creek. Damage resulting from this flood was extensive throughout the study area, with the Borough of Sellersville being hardest hit. Figures 2 and 3 show photographs of the August 1942 flood in the Sellersville area.

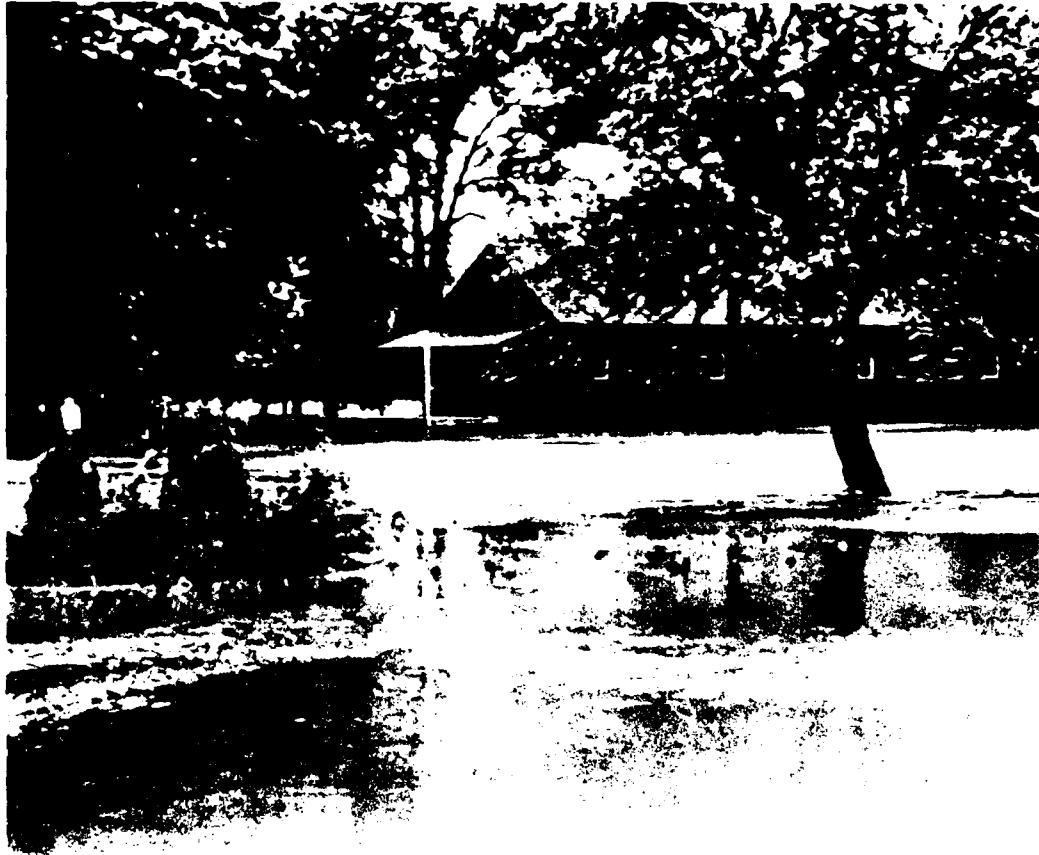
**FIGURE 4** - Lenape Park in Sellersville during the June 22, 1972, flood.

June 22, 1972 - Heavy rains associated with Tropical Storm Agnes caused the East Branch Perkiomen Creek to overflow its banks on this date. A Boy Scout Cabin in Lenape Park, Sellersville, was surrounded by water and is shown in Figure 4. U.S. Route 309 was covered with water but was not closed.

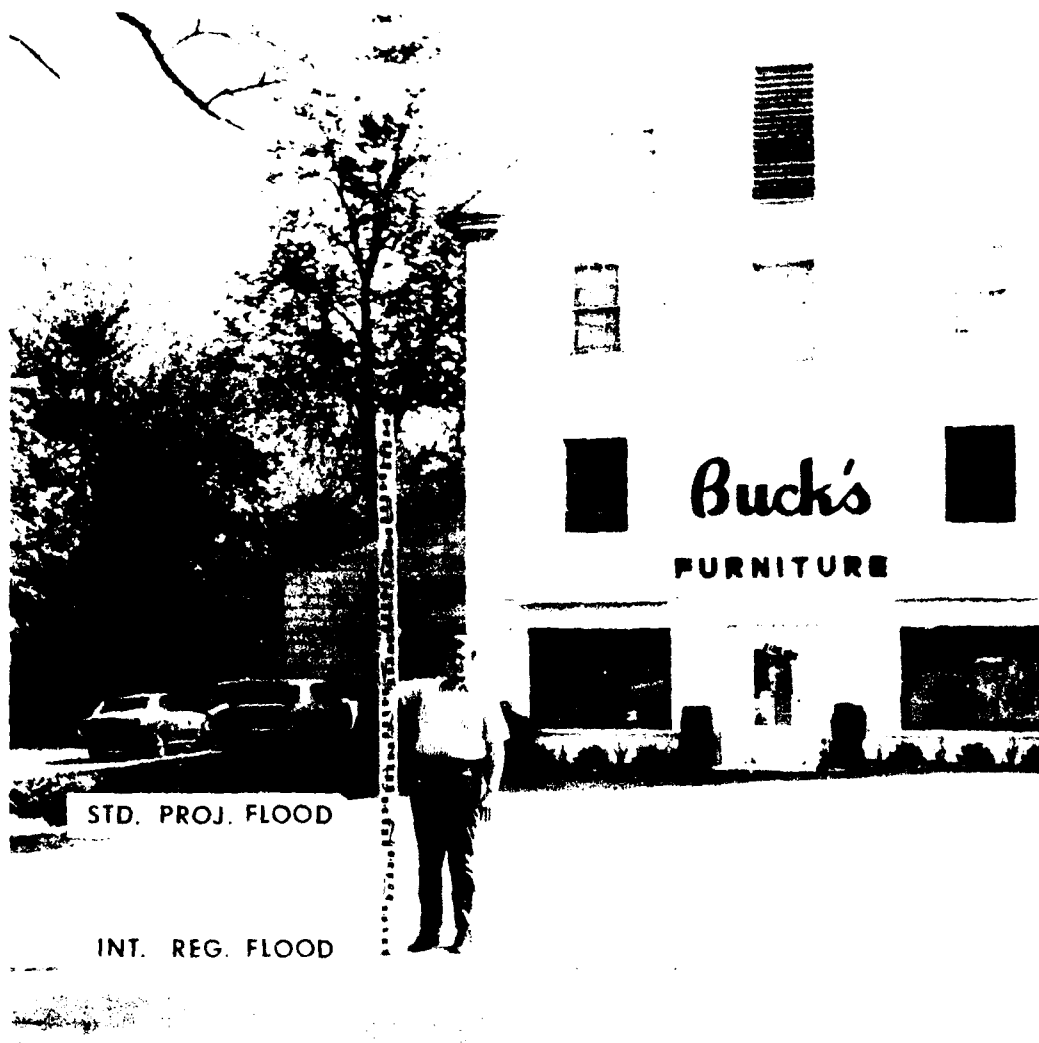
FIGURE 5 - Possible future flood heights at Buck's Furniture Store in Sellersville.

Photographs, future flood heights - The levels that the Intermediate Regional and Standard Project Floods might reach at various locations in the East Branch Perkiomen Valley are indicated on the following photographs.

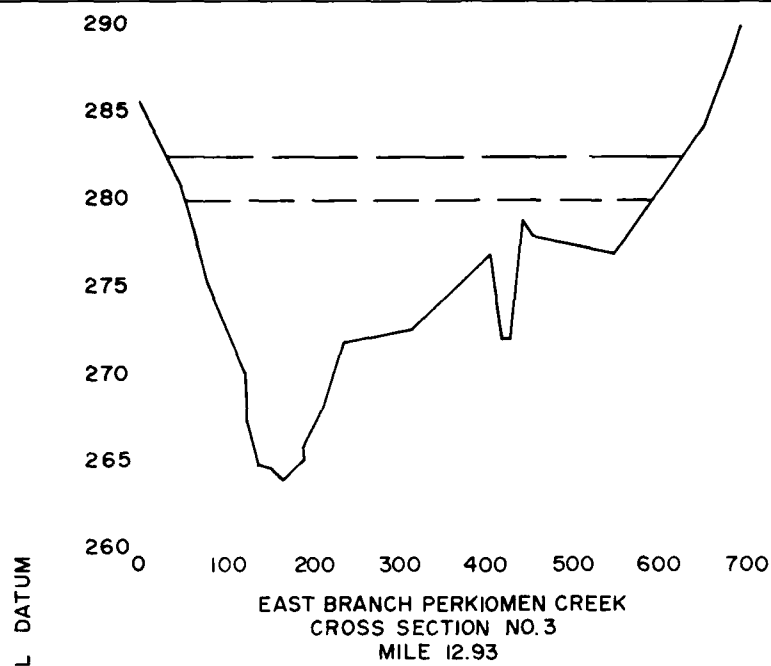
DEPARTMENT OF THE ARMY  
PHILADELPHIA DISTRICT, CORPS OF ENGINEERS  
PHILADELPHIA, PENNSYLVANIA  
FLOOD PLAIN INFORMATION  
EAST BRANCH PERKIOMEN CREEK  
BUCKS AND MONTGOMERY COUNTIES, PA  
SELECTED CROSS SECTIONS  
EAST BRANCH PERKIOMEN CREEK  
AND INDIAN CREEK

The areas that would be flooded by the Intermediate Regional and Standard Project Floods include farmland and scattered commercial and residential properties, along with the associated streets, roads, and private and public utilities in the study area. Considerable damage to these facilities would occur during an Intermediate Regional Flood. However, due to the wider extent, greater depths of flooding, higher velocity flow and longer duration of flooding during a Standard Project Flood, damage would be even more severe than during an Intermediate Regional Flood. Plates 13 through 18 show water surface profiles for the Intermediate Regional and Standard Project Floods. Depth of flow in the channel can be estimated from these illustrations. Typical cross sections of the flood plain at selected locations, together with the water surface elevation and lateral extent of the Intermediate Regional and Standard Project Floods are shown on Plates 19 and 20.

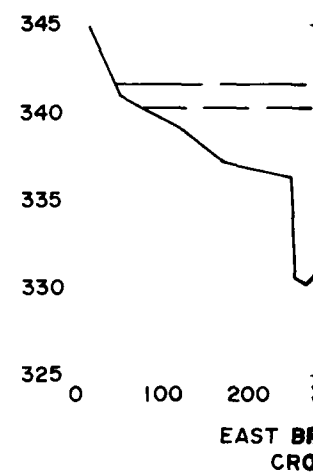
- Standard Project Flood
- - - Intermediate Regional Flood
- Ground Line

DEPARTMENT OF THE ARMY  
PHILADELPHIA DISTRICT, CORPS OF ENGINEERS  
PHILADELPHIA, PENNSYLVANIA  
FLOOD PLAIN INFORMATION  
EAST BRANCH PERKIOMEN CREEK  
BUCKS AND MONTGOMERY COUNTIES, PA.  
SELECTED CROSS SECTIONS  
EAST BRANCH PERKIOMEN CREEK

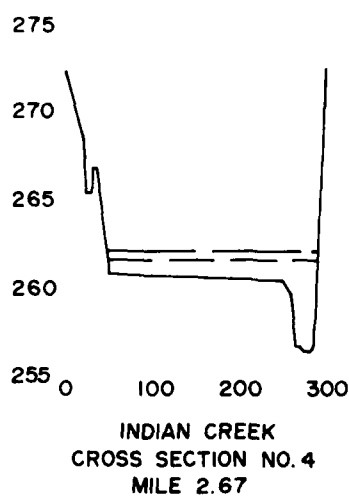
- — — — — Standard Project Flood
- - - - - Intermediate Regional Flood
- Ground Line
